Buyers Guide to:

Volkswagen Type 25

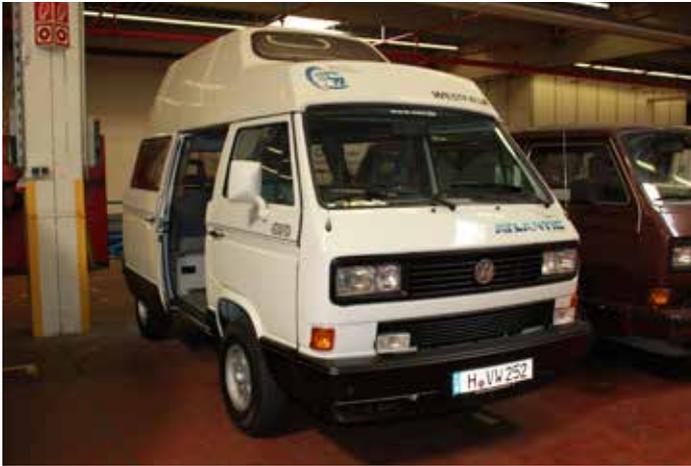
Corrosion Hotspots

1. Outer front panel behind the bumper
2. Front screen surround
3. Door bottoms and front steps
4. Floorpan
5. Inner and outer sills
6. Chassis legs including outriggers
7. Side window surrounds
8. Rear quarter panels and wheel arches
9. Rear swing arm mounts and spring seats
10. Rear valance and bottom of the tailgate
