Buyers Guide to:

Volkswagen Beetle

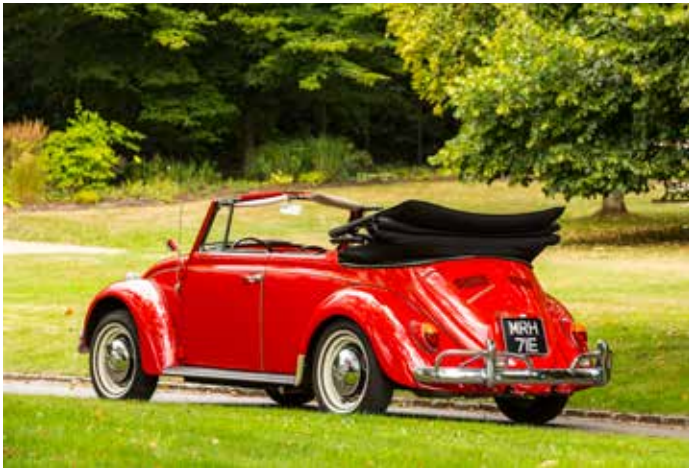
Corrosion Hotspots

1. Chassis frame head beneath the luggage compartment
2. Spare wheel well
3. Front and rear bumper mounts
4. Edges of the luggage compartment lid
5. Inner and outer front wings
6. Bottom of the A-pillar and windscreen surround
7. Sills/heater channels, and surrounding floor section
8. Rear quarter panels and inner rear wings
9. Floorpan, front to rear
10. Door bottoms
