## REAR SEAT BELTS

### T25 1979-1992

Part Numbers: J13005

#### FITTING GUIDE

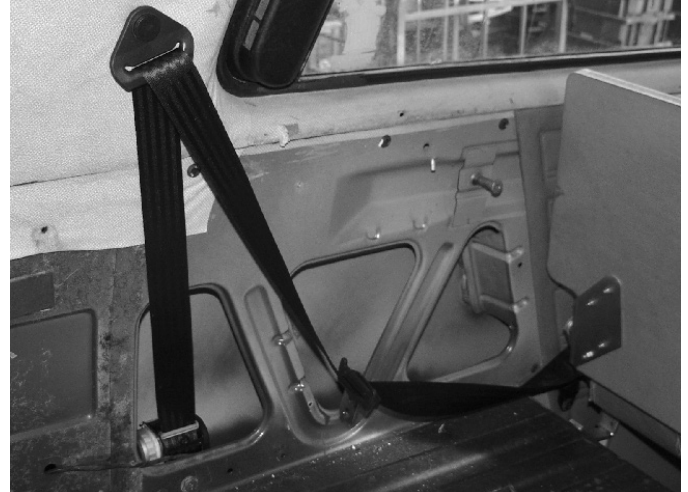
1. A fitted rear seat belt.

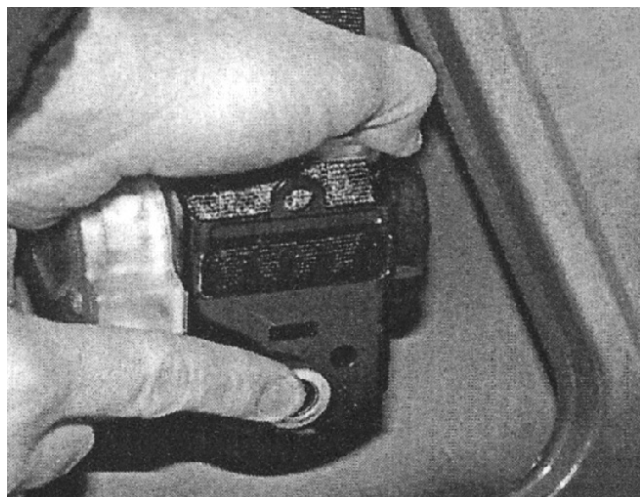
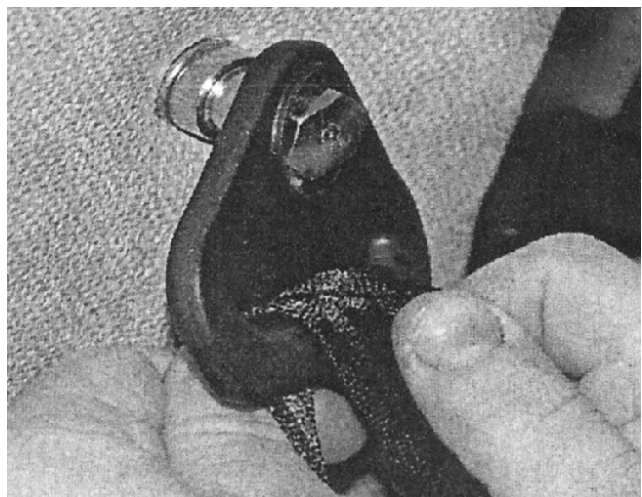
5. Fit the reel on the inside panel, pushing the bolt through the fixing hole first. Then add one flat washer and the seat belt reel and fasten together using the nut provided. You will notice that the belt is twisted and will require untwisting.

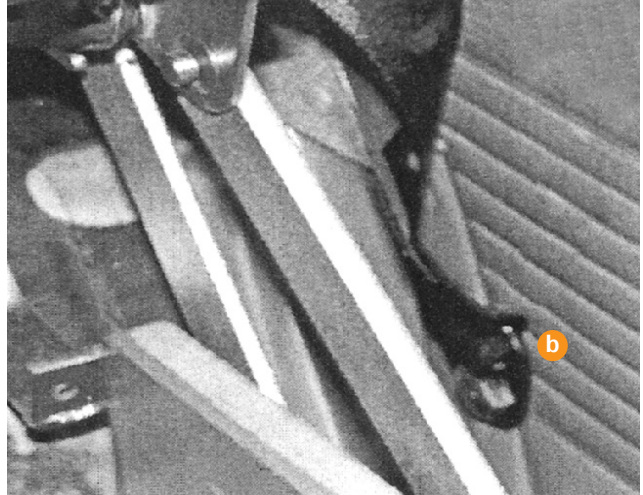
7. Locate the bottom seat belt mounting point, down the side of your bed (b). Using a bolt, fasten the bracket to the panel.
