Buyers Guide to:

Volkswagen Type 2 Split Screen

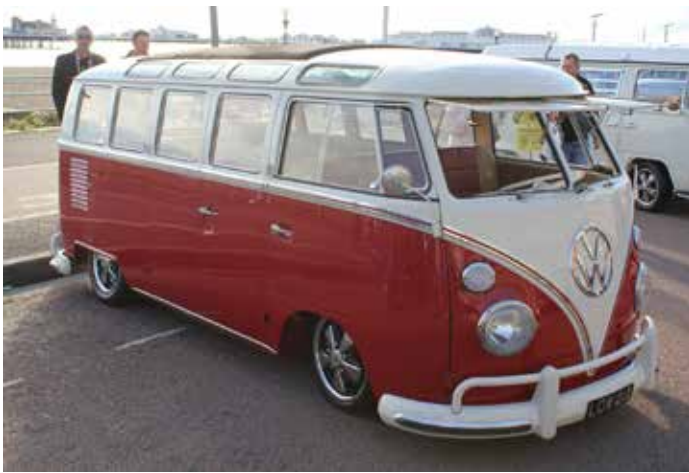
Corrosion Hotspots

1. Lower front panel and inner front valance
2. Roof gutters
3. Front screen surround
4. Front roof panel around the airbox
5. Chassis legs front to rear, including outriggers and jacking points
6. Floorpan
7. Door bottoms
8. Bottom of the tailgate/engine lid
9. Inner and outer wheel arches
10. Inner and outer sills
11. Around the side windows
12. Rear corner of the engine bay, including the battery tray
13. Rear inner and outer lower valance
