Buyers Guide to:

Volkswagen T5

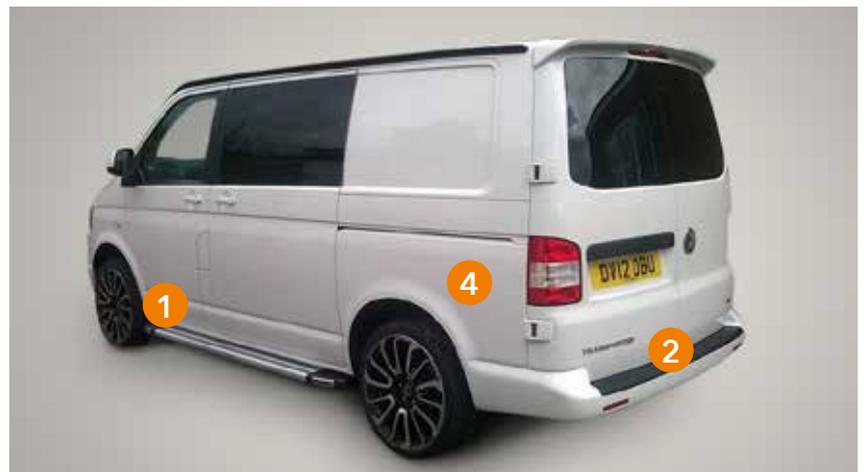
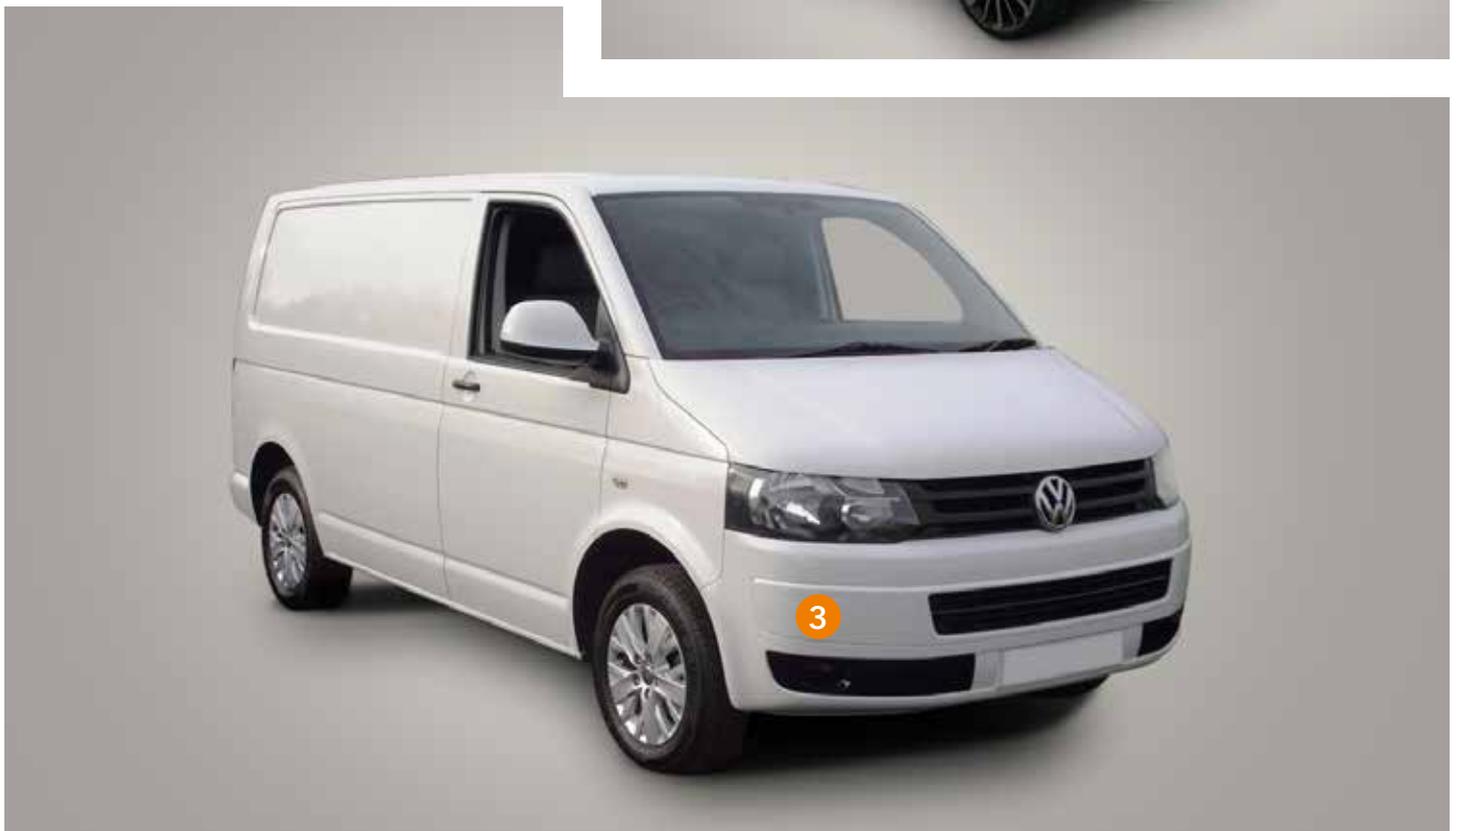
Corrosion Hotspots

1. **Bottom of the front doors**
2. **lower edge of the tailgate/rear doors**
3. **Stone chips around the front panel**
4. **General panel damage; scrapes, scuffs etc**
